## 1. BACKGROUND

## 2. JUNE 2016 STORM

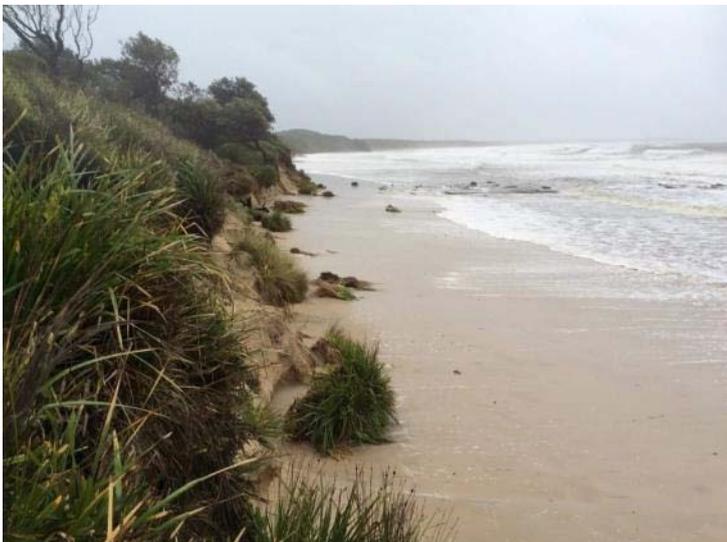
Based on surveys undertaken by Council, it has been estimated that 20,000 m<sup>3</sup> of sand was eroded from Warrain Beach in the June storm event (Advisian). Severe erosion was experienced along the Warrain Crescent shoreline and also at Beecroft Parade. All beach access stairs at Warrain Crescent were destroyed. Photos below.

East end of Warrain Crescent looking west; mid reef in middle ground

A remedial project, to be implemented in the coming months (subject to approvals), aims to accelerate the return of eroded sand to the beach face and to replace two beach access stairs. This work will be carried out by the Soil Conservation Service (Nowra), and will comprise

- Removal of sand by excavator from western edge of creek inlet to reuse for beach replenishment
- Beach scraping along Warrain Crescent and placement of woody debris to high tide dune scarp
- Placement of excavated sand at toe of beach scarp at Warrain Crescent (between two reefs)
- Replacement of washed out beach access stairs at Currarong Creek and Worrigeer Street.

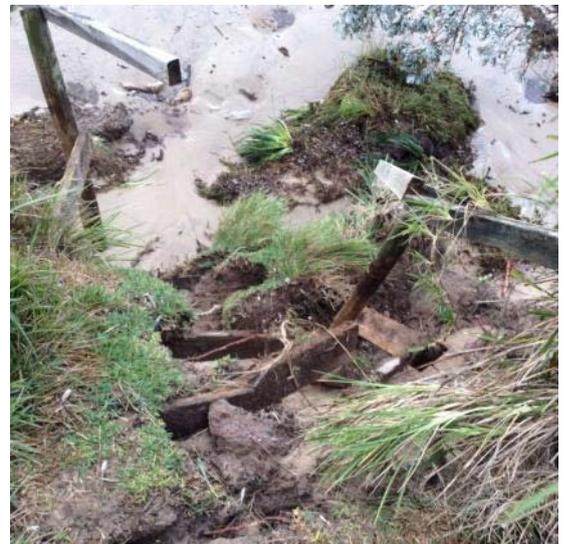
Beach access stairs destroyed at Warrain Crescent

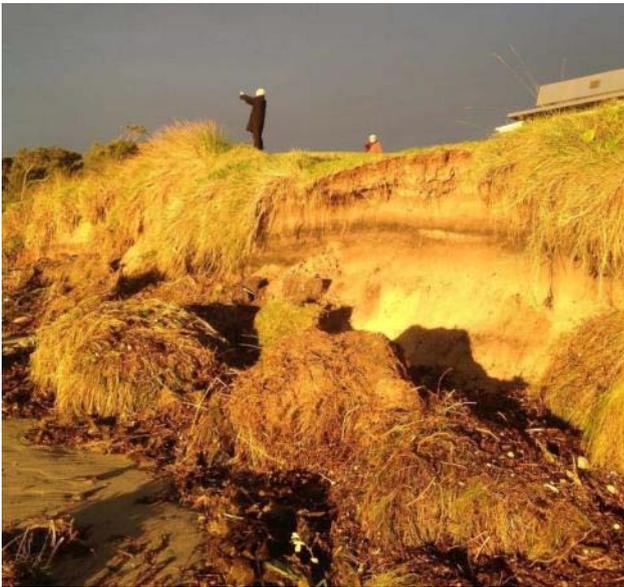
Erosion at Beecroft Parade

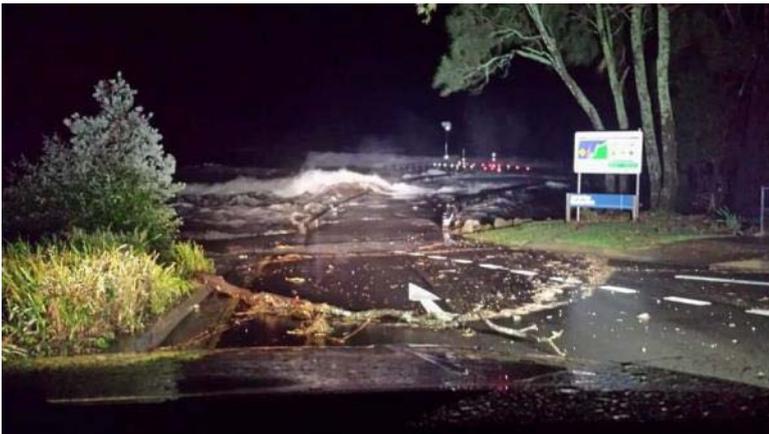
Yalwal Street boat ramp approx. 9pm Sunday June 6. Wave run up debris line estimated at 3.5m AHD (Photos courtesy of Dave & Gina Thornton).

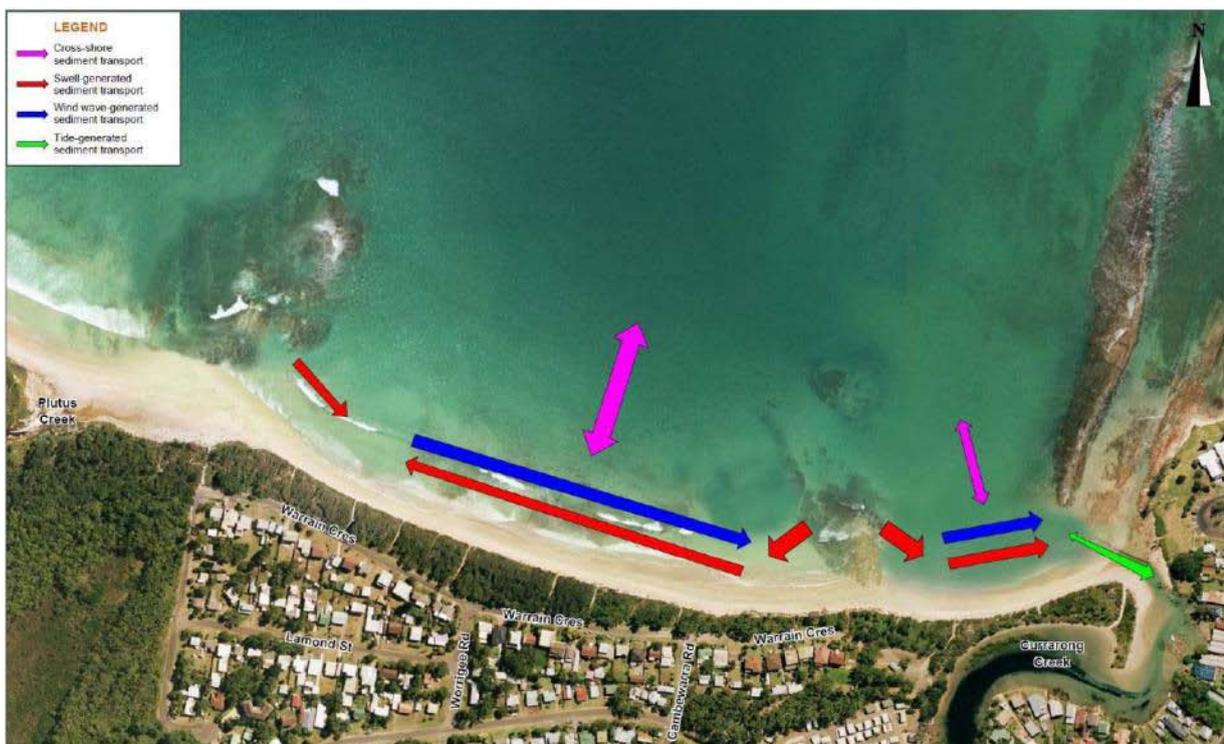
### Conceptual model of sediment transport (SMEC, 2012)

The important and high weight 'effectiveness of the option' criterion, relied upon an understanding of sediment transport processes. This was investigated in some detail by SMEC who modelled the swell and locally generated sea wave climate to derive sediment transport pathways and develop a conceptual model of sediment transport – see diagram below.

The model shows that wind waves lead to a W to E sediment transport potential along the full length of Currarong Beach (blue arrows), while swell waves lead to transport potential both towards the E and W, with central reef forming the null point. The unidirectional transport, east of the central reef towards the creek, contributes to the relatively high rate of sand infilling.

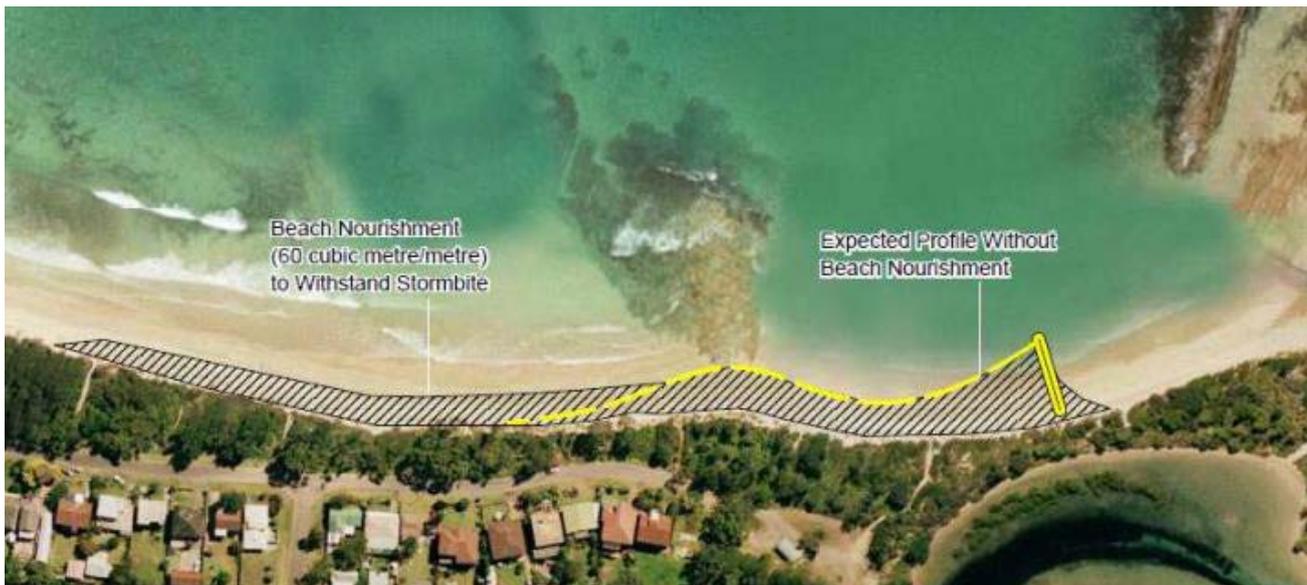
### **Groyne and beach nourishment scheme**

A general arrangement for the preferred groyne and nourishment concept is shown in below.

There has been some discussion on the positional detail for the groyne between the central reef and the creek entrance. OEH has suggested that the groyne position should be about 60 m closer to the creek than is recommended by SMEC. This can be addressed in the detailed design.

The final recommendation by SMEC was to construct a geotextile groyne at the narrowest part of the spit and place the 15,000 m<sup>3</sup> of nourishment sand. This would reduce the risk of a breakout of the creek through the spit, prevent loss of sand into Currarong Creek by trapping the west to east movement along the beach and provide a storm erosion buffer to the eastern end of Warrain Crescent which is most exposed to wave erosion.

The geotextile groyne would have a relatively short design life. SMEC suggests around 5 years, although recent experience from Stockton Beach and Maroochydore indicates that a 10 to 15 year life, with suitable maintenance, is probable.

The intention would be for the geotextile container structure to operate as a trial scheme, with regular surveys to monitor its effectiveness. If the groyne and nourishment scheme proves to be successful in mitigating storm erosion to Warrain Beach, and the community is satisfied that beach amenity is not unduly impacted, then there would be a strong case for Council to consider replacing the geotextile container groyne with rock at the end of its useful life.

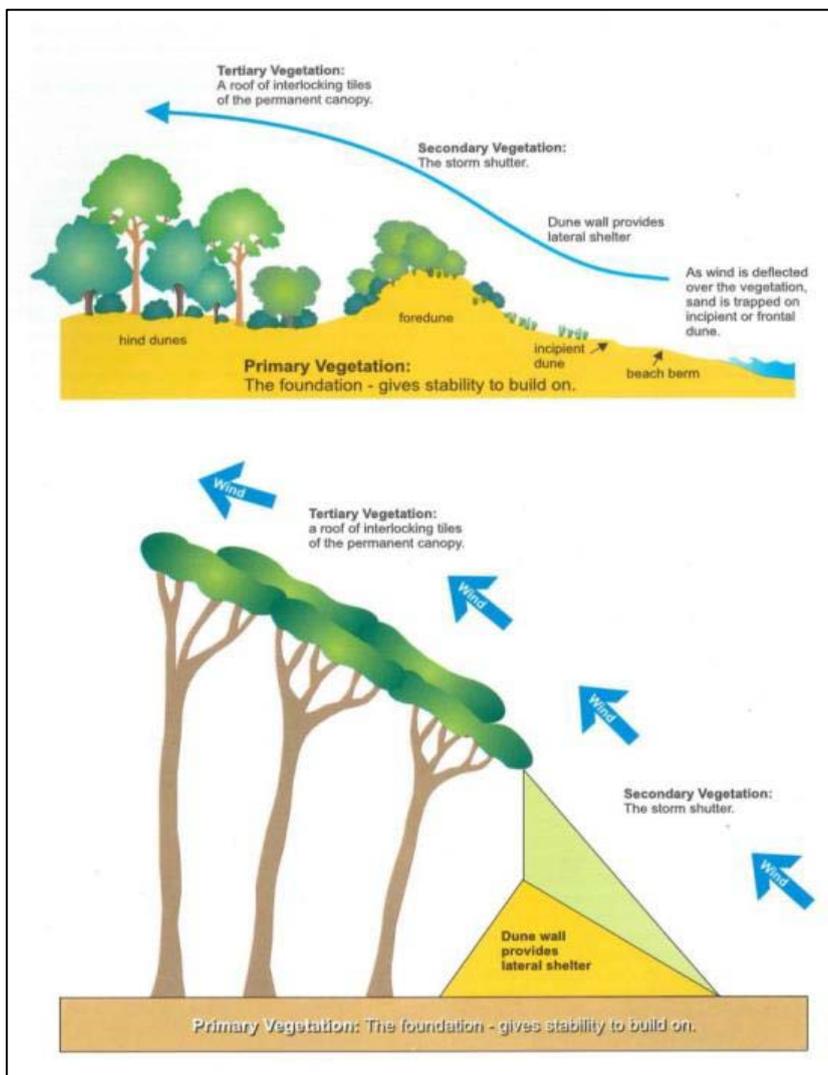
### Functional model of dune vegetation (DLWC, 2001)

*“The analogy is drawn between the (wind) protection afforded by a well vegetated dune system and that of a well constructed and maintained cyclone-proof house. Primary zone species (grasses and creepers) colonise the lower parts of the beach and trap abrasive sand particles forming a “foundation”. The foundation represents an elevated “wall” that can be colonised by secondary zone species (mainly shrubs) to provide a wind deflecting “shutter” near the shoreline. Finally a “roof” forms from the growth of tertiary species (taller shrubs and trees), further elevating the wind and providing increased shelter to vegetation further inland.....Dune stability relies on keeping the whole structure – “foundations”, “wall”, “shutter” and “roof” – intact. Damage to any component can cause deterioration in other parts.”* (Section 2.8.1, p20). See below.
